September 11 – October 2:

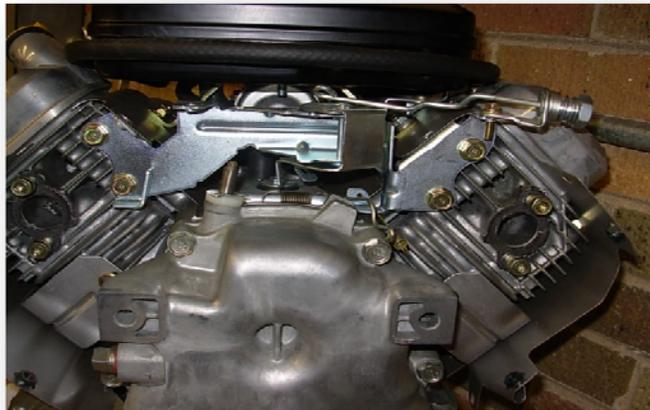
- Here is a picture of the bottom of the engine before the throttle change (Below).

We have removed the governor of the Briggs engine to allow an increase in rpm and throttle control. We replaced the governor with a threaded rod and lock nuts, and then added an adjustable throttle to allow revving of the engine. After the modifications to the engine were completed, we started to cut the steel to the appropriate sizes for the base of the chassis. Our team had some difficulties at first with the front end. We did not line the steel up correctly, which we did not notice until after welding the pieces together. The steel for the front end was welded at odd angles which gave the front end a teeter totter effect at the corners. We remade the front end which put us behind a day or two. We made up for this delay by staying after school to cut and assemble as much of the chassis as possible. We were able to weld both roll bars onto the chassis as well as most of the side brace tubing.

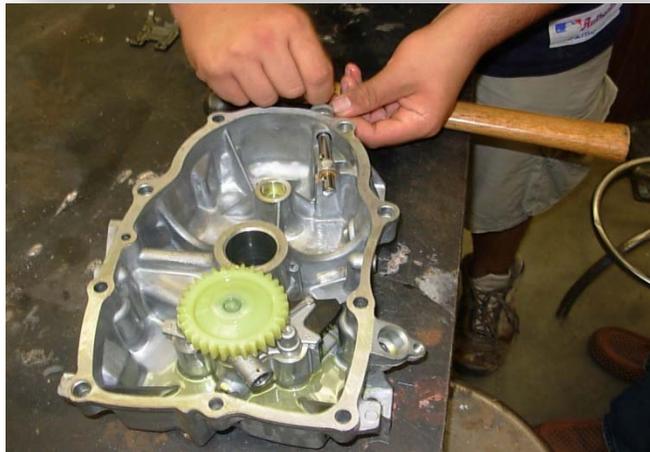
- Jordan is removing the governor (Above). He replaces it with a bolt and some lock nuts (Below).

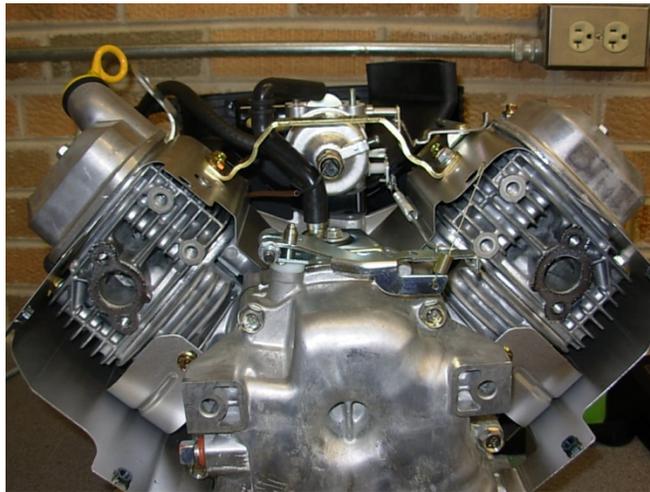
- We finished the modifications up with an adjustable throttle mounted on the side of the engine (Shown Below).

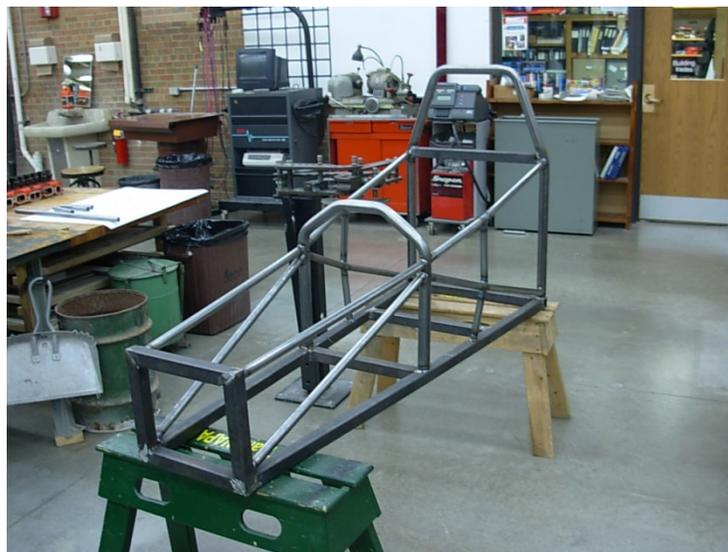
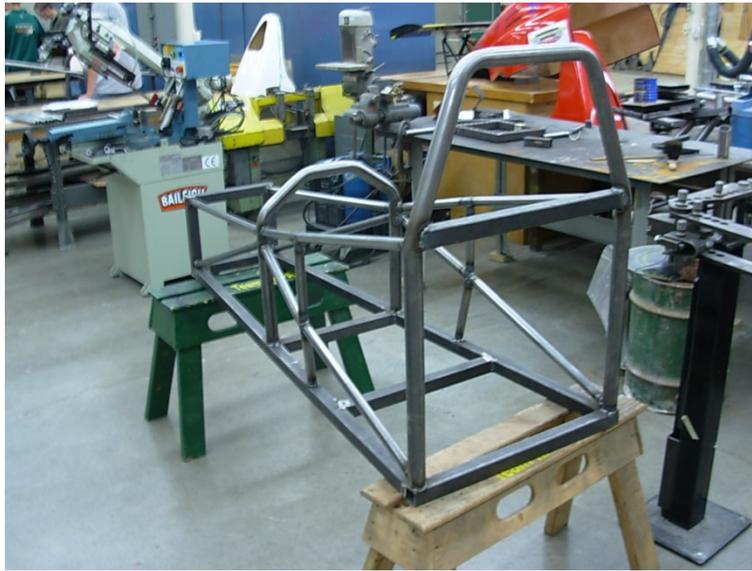
- With the modifications to the throttle completed. We moved on to cutting and welding the steel for the base of the chassis (Shown below, not yet completed).
